Subject: Clean Water Act Compliance Evaluation Inspection Report

**CWA COMPLIANCE EVALUATION INSPECTION REPORT  
U.S. ENVIRONMENTAL PROTECTION AGENCY, REGION 5**

**Facility:** Windy Ridge Dairy  
1652 North CR 1100 West  
Fair Oaks, Indiana 47943

**Date of Inspection:** October 31, 2013

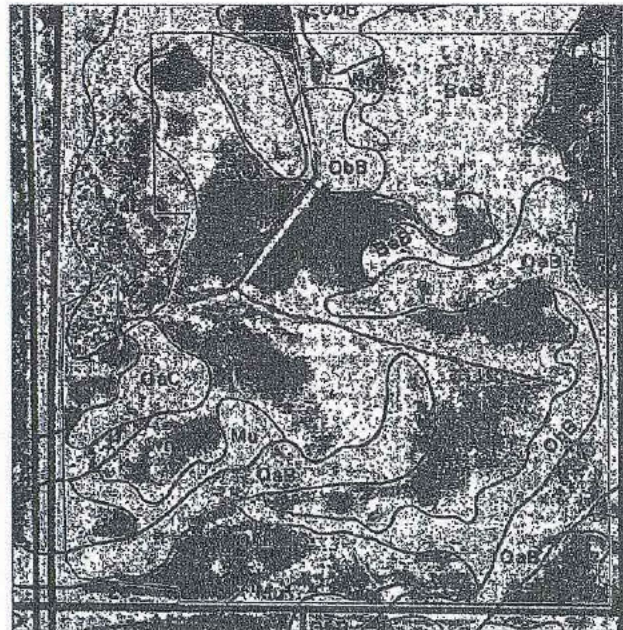
Field: System 11

255 Available Acres

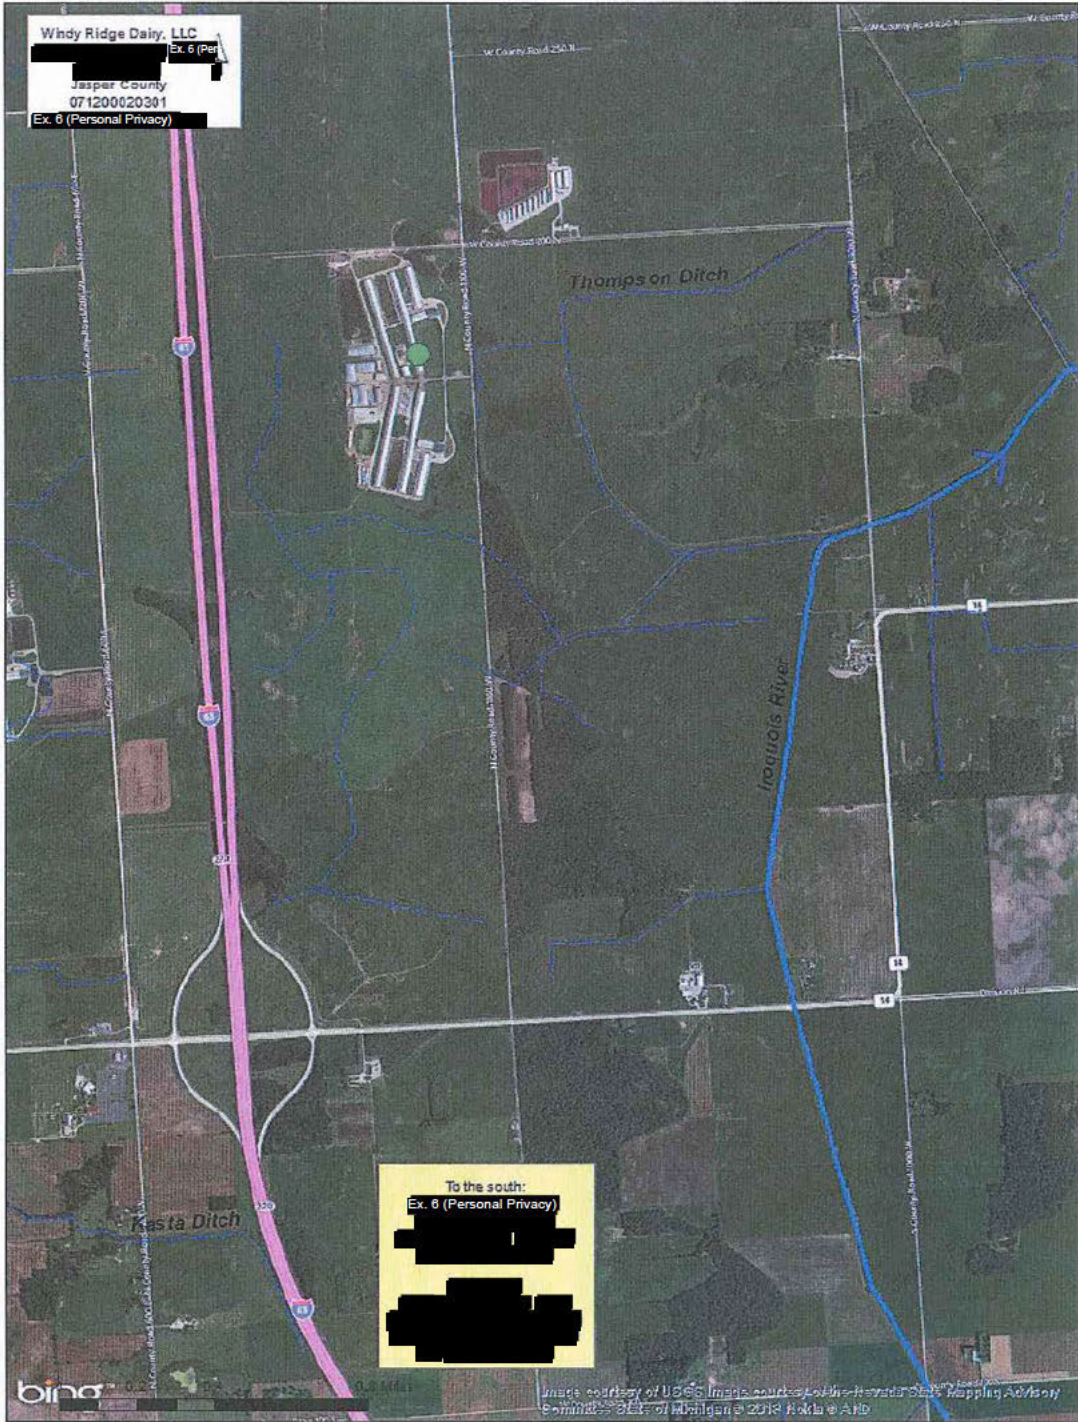
Figure 4.1: Windy Ridge Dairy Facility Layout: Note P1 is now synthetically lined and used as a waste storage pond.

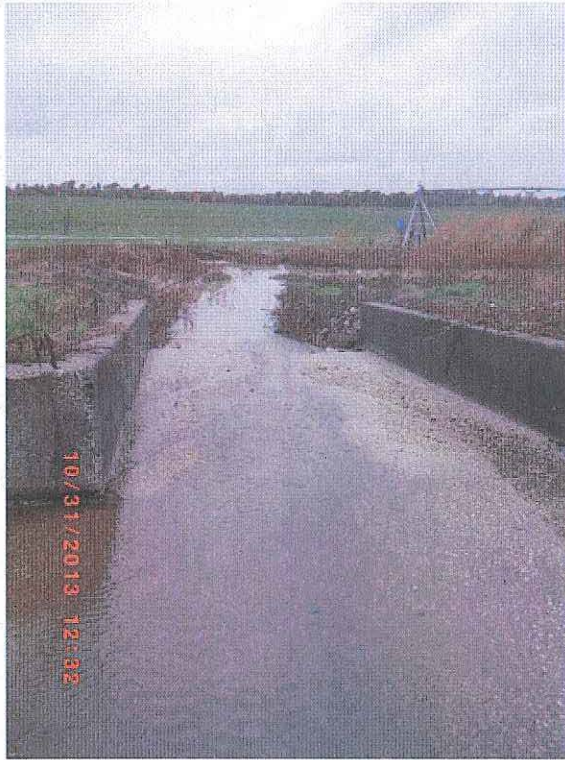
1: IMGP0372.JPG

Description: On the west end of the facility, runoff from the Silage Pad, E18, flows west through this system in which the silage leachate is collected and transferred to Wastewater Storage Pond, E21. A portion of the process wastewater bypassed the collection system and flowed west from E18 into a ditch.

1. Windy Ridge Dairy did not containing all the process wastewater generated at the Silage Pads and other feed storage areas. The process wastewater could flow into ditches that flow out to Field 9. If process wastewater discharges to a Water of the United States (WOUS), it would be violation of the CWA.
2. An overview of the application records indicated that Windy Ridge Dairy may be applying manure in excessive quantities to Fields 6, 9, and 11. Additionally, manure application occurred on the same day as rainfall events. The land application records did not document soil or weather conditions at the time of application. If manure or process wastewater discharges to a WOUS due to inadequate site specific nutrient management practices, it would be a violation of the CWA.

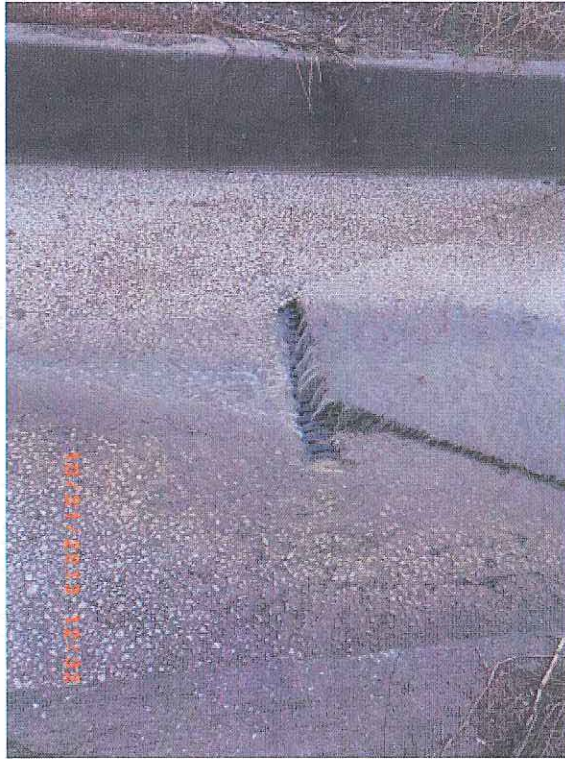
2: IMGP0373.JPG

Description: On the west end of the facility, runoff from the Silage Pad, E18, flows west through a system in which the silage leachate is collected and transferred to Wastewater Storage Pond, E21. A portion of the process wastewater bypassed the perforated pipe and flowed west from E18 into a ditch adjacent to the west side of the E18. Subsequently, the bypassed process wastewater runoff flowed from the ditch into Field 9 along the west end of the facility.

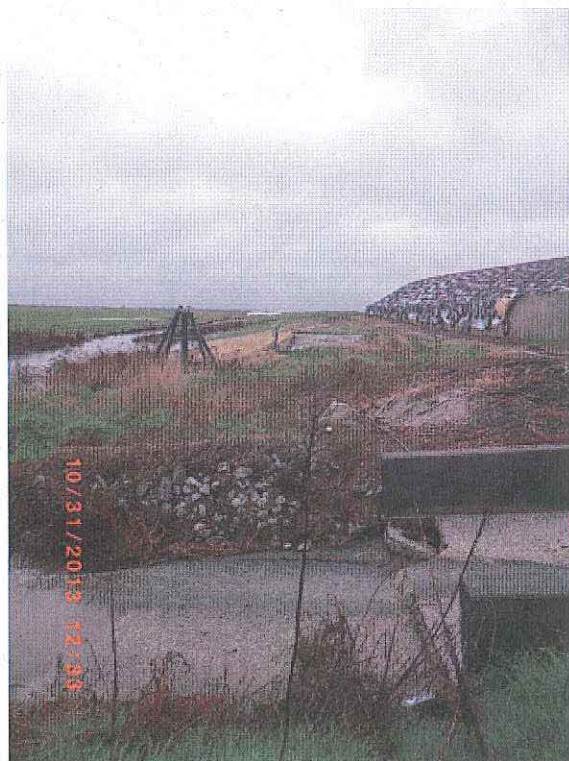
3: IMGP0374.JPG

Description: A portion of the process wastewater bypassed the collection system and flowed west from E18 into a ditch adjacent to the west side of the E18. Subsequently, the bypassed process wastewater runoff flowed from the ditch into Field 9 along the west end of the facility.

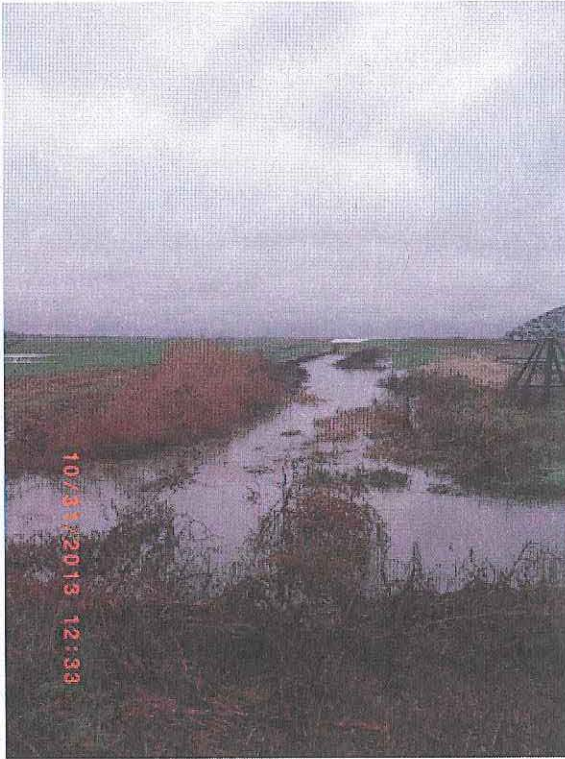
4: IMGP0375.JPG

Description: A portion of the process wastewater bypassed the collection system and flowed west from E18 into this ditch adjacent to the west side of the E18. The bypassed process wastewater runoff flowed north in the ditch and outlet into Field 9 along the west end of the facility.

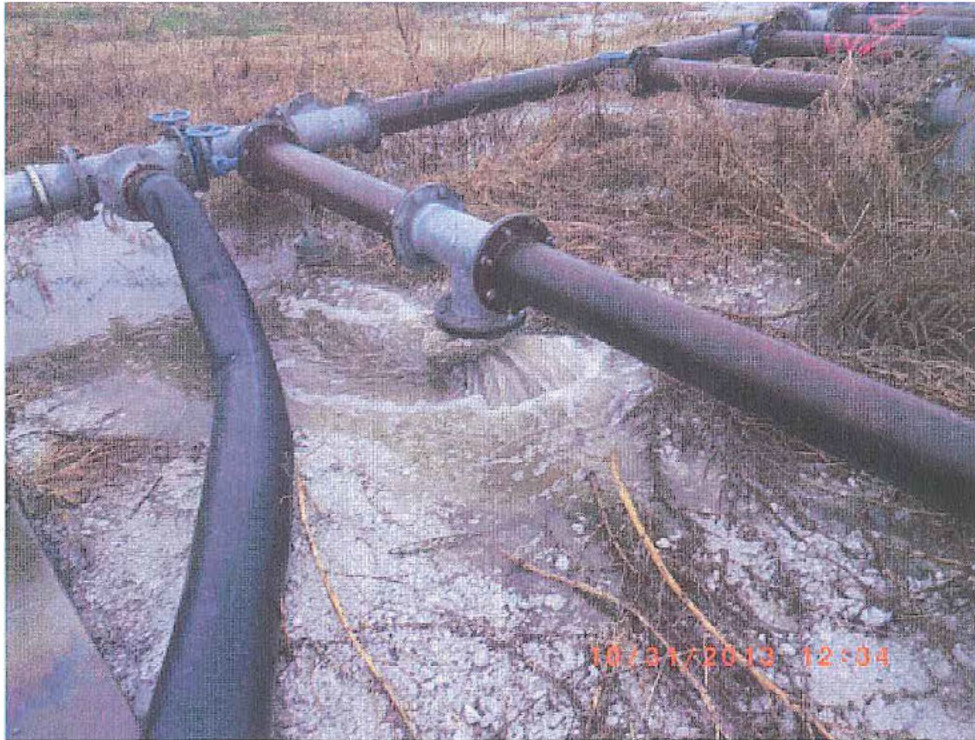
5: IMGP0376.JPG

Description: Water was flowing out of a break in a T connection of a well pipe system located west of E18. Ex. 6 (Personal Privacy) believed that the water was being transferred through a break in an abandoned center pivot irrigation pipe located to the north of the well pipe system near the ditch adjacent to the west side of E18.

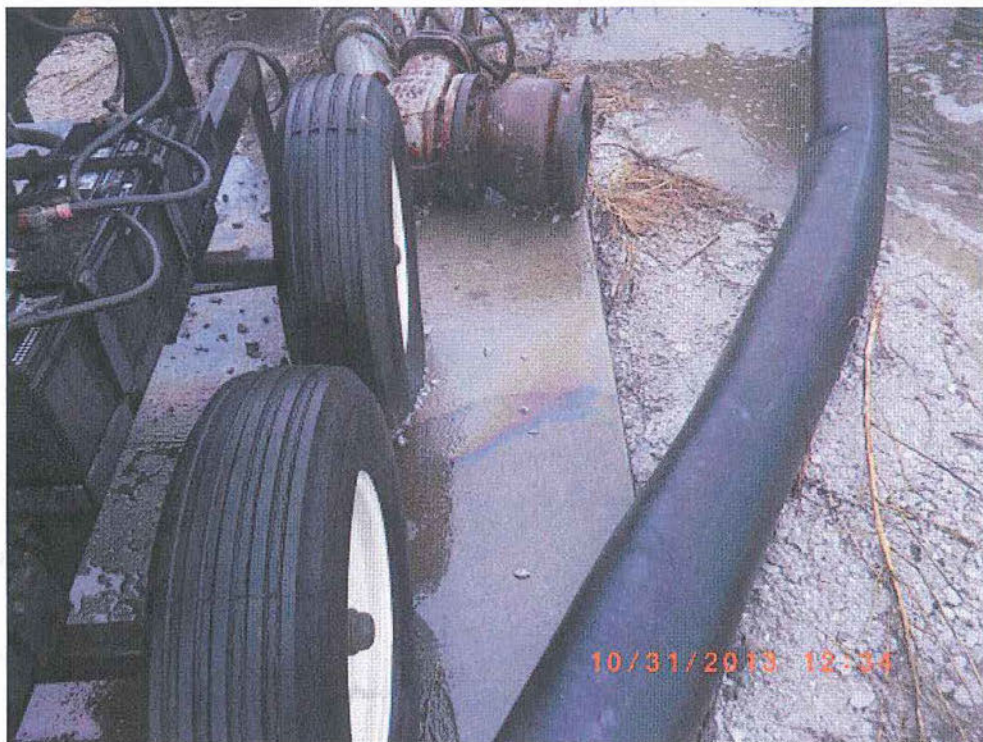
6: IMGP0377.JPG

Description: Slight oil staining near a pump near the well pipe system.

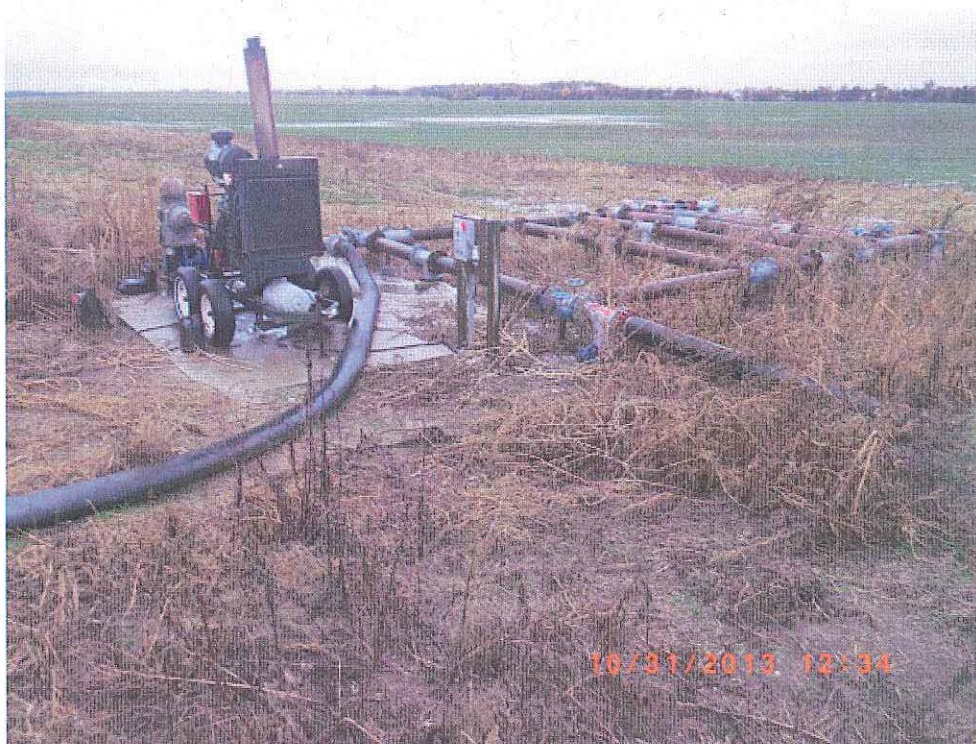
7: IMG0378.JPG

Description: The pump and well pipe system.

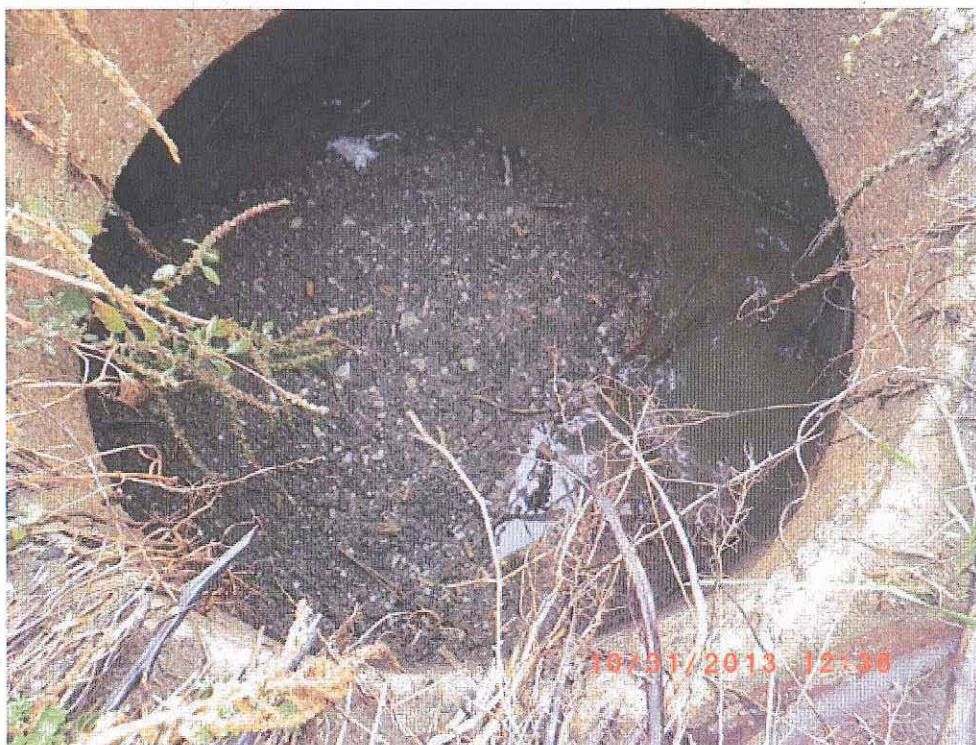
8: IMGP0379.JPG

Description: Near Silage Pad, E19, a manhole in the transfer system for the silage leachate collection system contained solids buildup.

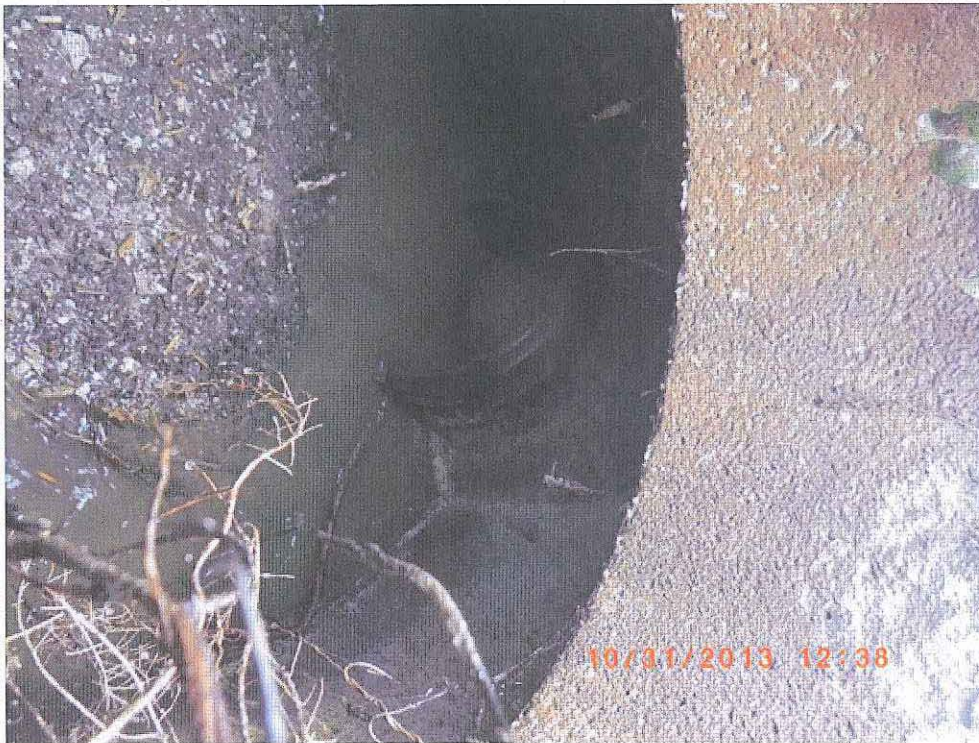
9: IMGP0380.JPG

Description: The process wastewater flows out of the pipe. The manhole in the transfer system for the silage leachate collection near Silage Pad E19 contained solids buildup.

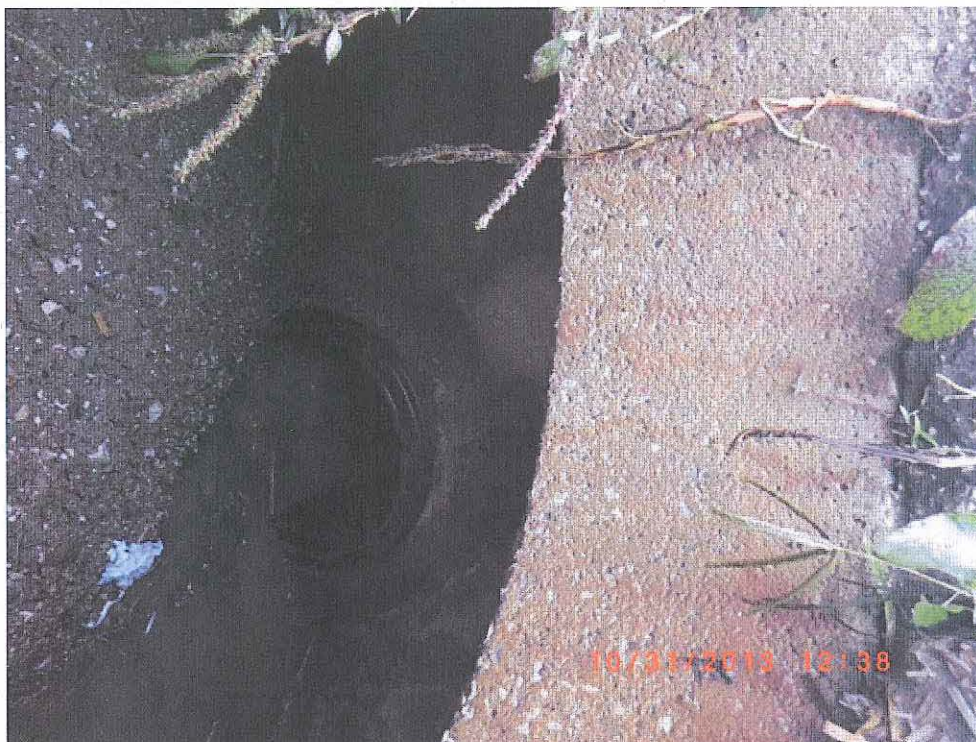
10: IMGP0381.JPG

Description: The process wastewater flows out of the pipe. The manhole in the transfer system for the silage leachate collection near Silage Pad E19 contained solids buildup.

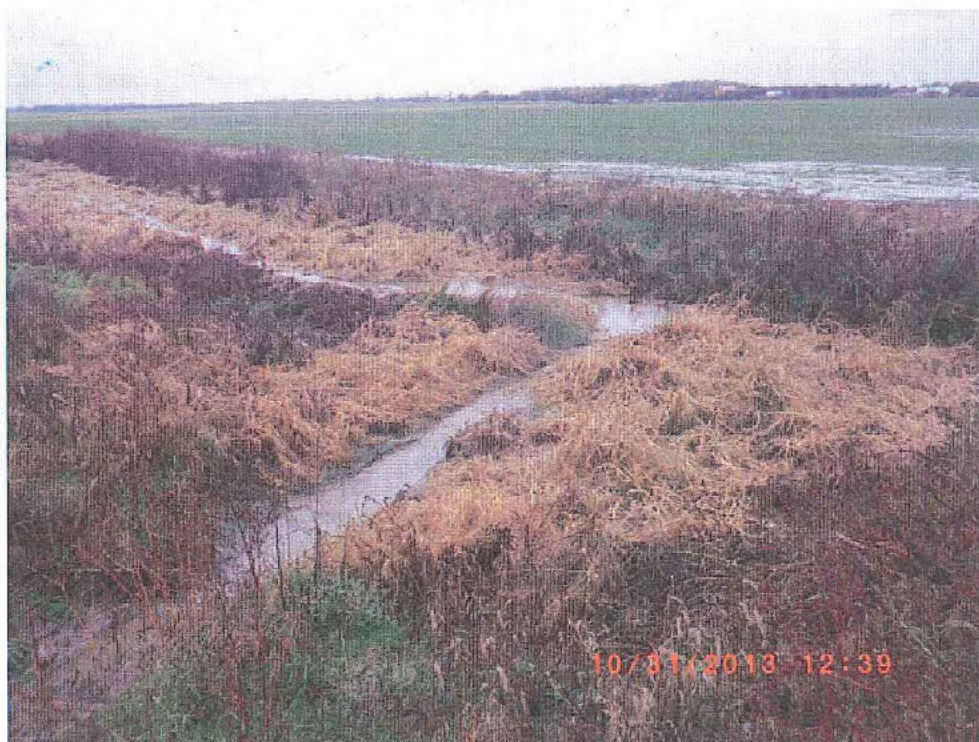
11: IMGP0382.JPG

Description: On the west end of the facility, a portion of the process wastewater from silage pad, E19, bypassed the silage leachate collection system. The bypassed process wastewater flowed west from E19 into this ditch adjacent to the west side of the E19. Subsequently, the bypassed process wastewater runoff flowed south in the ditch and west into Field 9 along the west end of the facility.

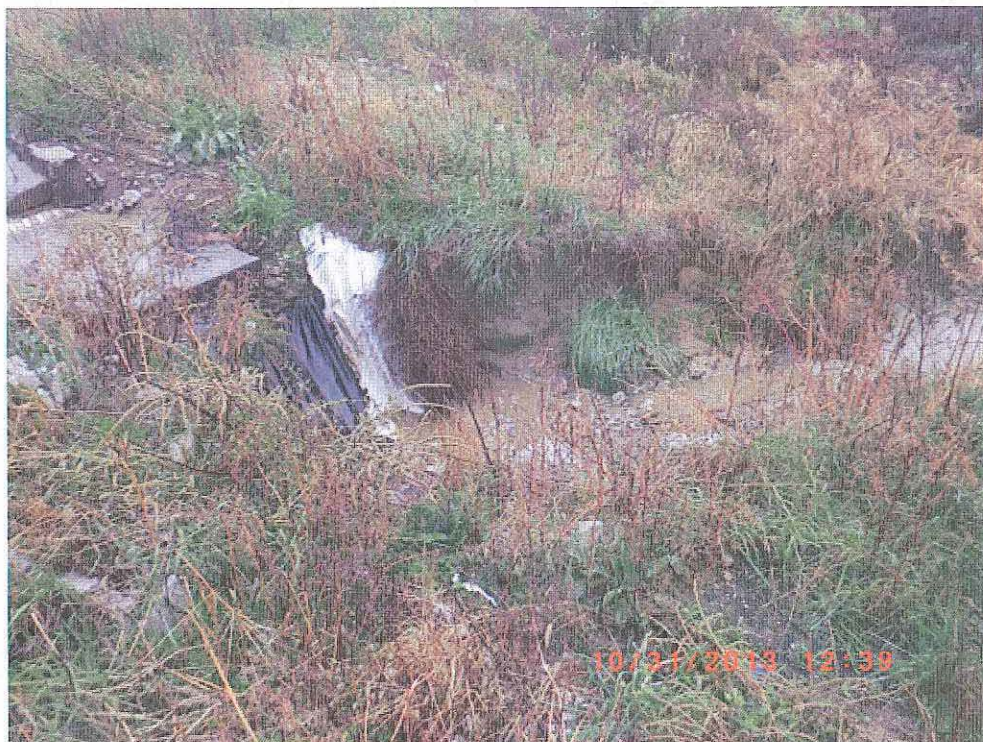
12: IMG0383.JPG

Description: Process wastewater flowed west from E19 into this ditch adjacent to the west side of the E19. The process wastewater enters the ditch near the concrete structure. Erosion had occurred due to inadequate stabilization.

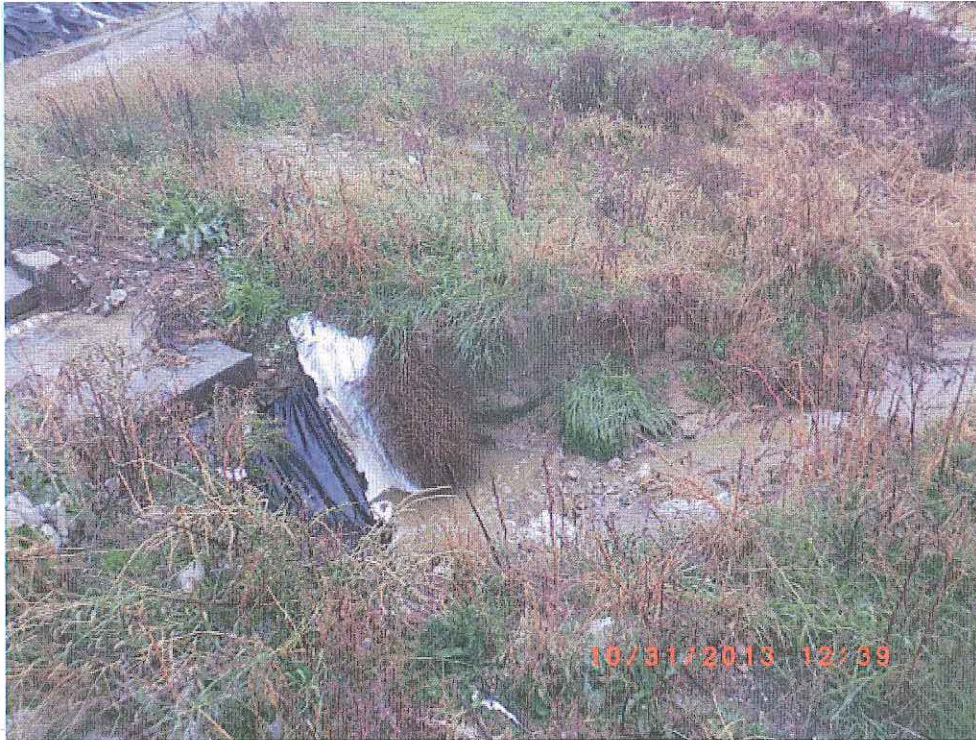
13: IMGP0384.JPG

Description: Process wastewater flowed west from E19 into this ditch adjacent to the west side of the E19. The process wastewater enters the ditch near the concrete structure. Erosion had occurred due to inadequate stabilization.

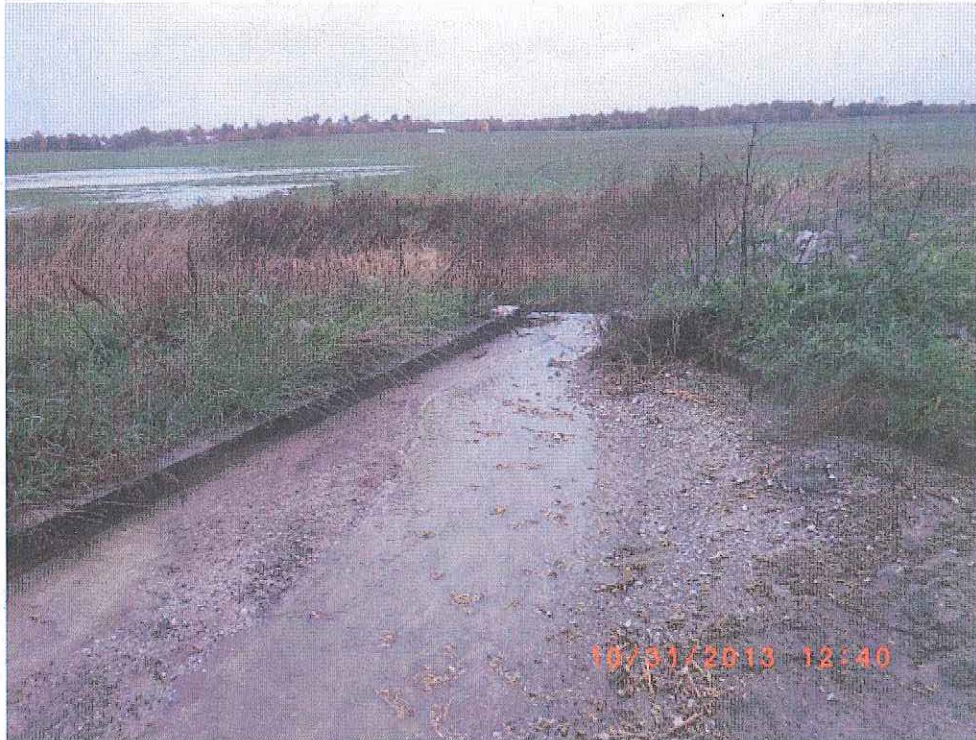
14: IMGP0385.JPG

**Description:** On the west end of the facility, runoff from the Silage Pad, E19, flows west through this system in which the silage leachate is collected with a perforated pipe near the end of the concrete structure and transferred to Wastewater Storage Pond, E21. A portion of the process wastewater bypassed the collection system and flowed west into a ditch.

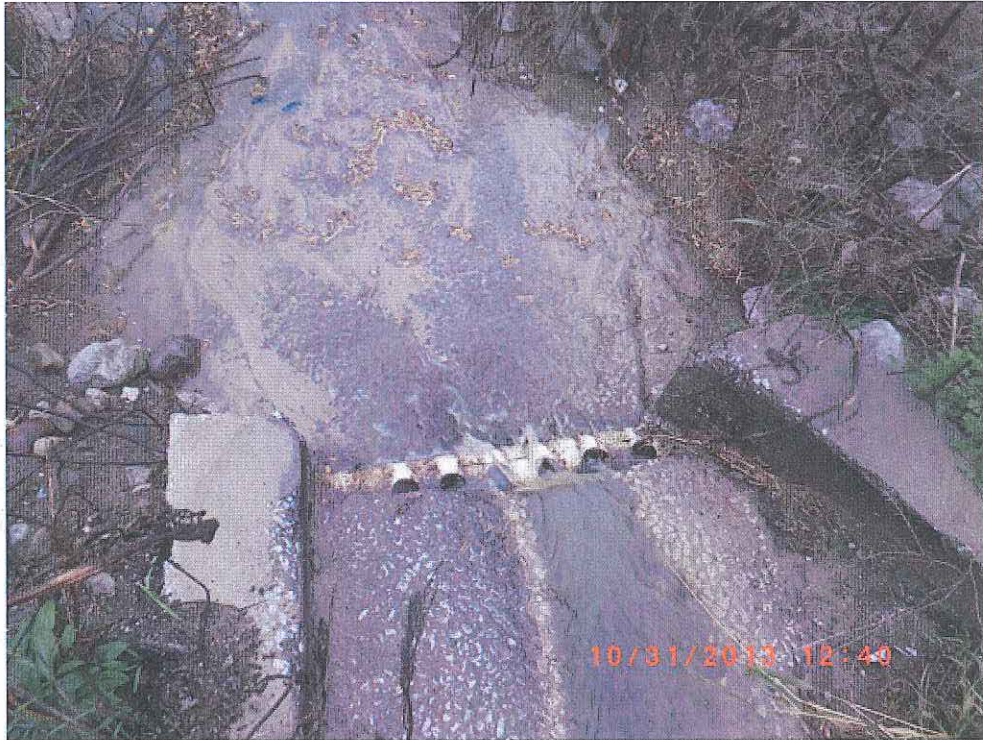
15: IMGP0386.JPG

Description: On the west end of the facility, runoff from the Silage Pad, E19, flows west through a system in which the silage leachate is collected and transferred to Wastewater Storage Pond, E21. A portion of the process wastewater bypassed the perforated pipe and flowed west into the ditch adjacent to the west side of the E19.
